# EMPLOYEE HAND THERMAL BURN INCIDENT

## Case Study

*Jason Grove and Steve Lambert*

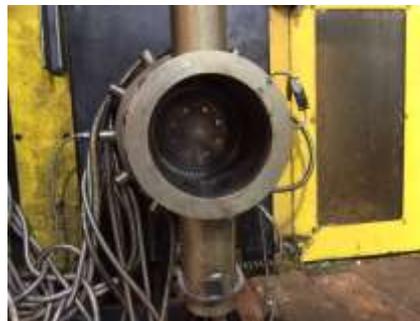
**Figure 1: Fully open water box**
